WATER LEAKS ALWAYS LEAVE A TRAIL

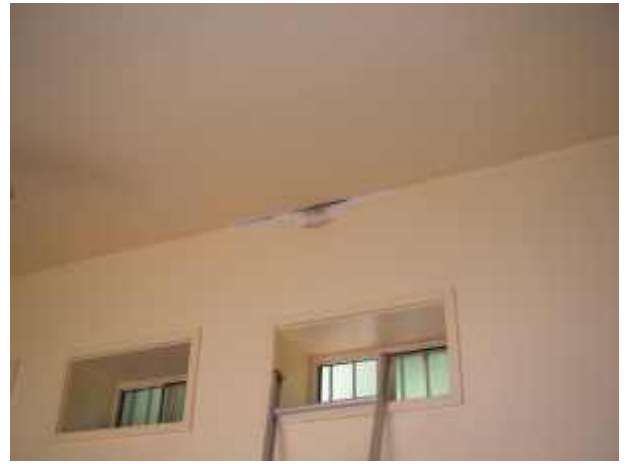
ANOTHER AREA OF DAMAGE
