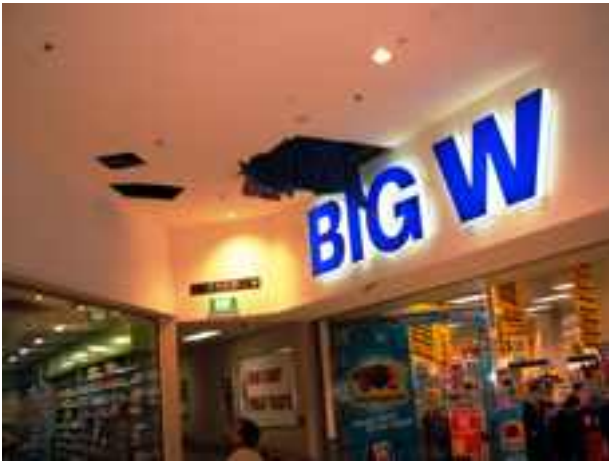
CUSTOMERS NEED RAIN COATS

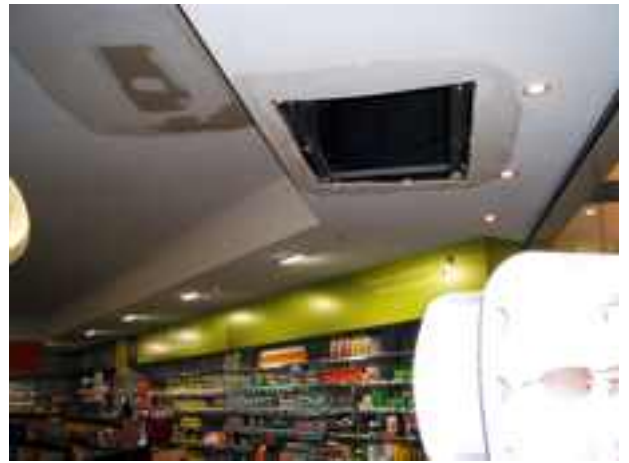
CEILING PATCHED BEFORE
EVENTUALLY IT FELL DOWN AGAIN

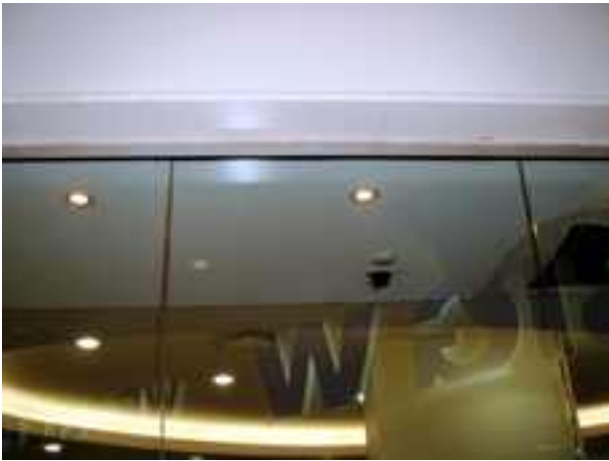
BUILT IN WINDOW WASHERS

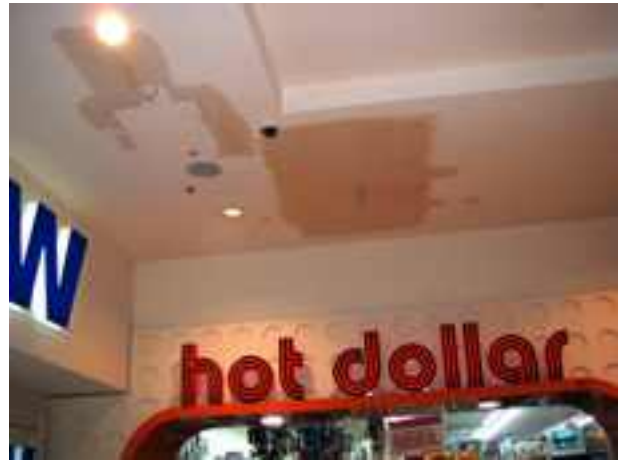
NEW PATCHES
NEW WATER LEAKS SHOWING

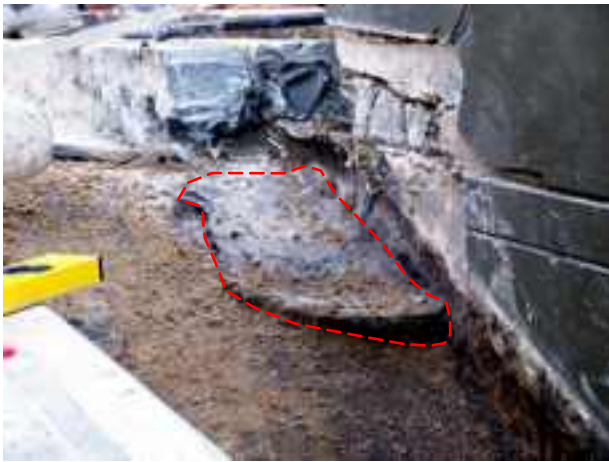
THE BLOB? NO, IT'S SUPPOSED
TO BE WATERPROOFING

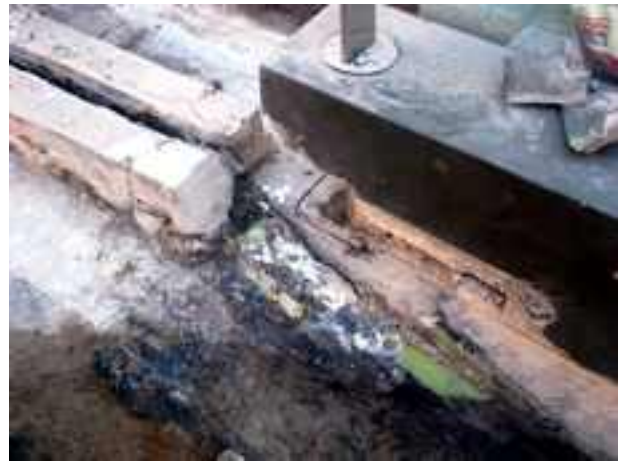
AND UNDER THE BLOB
THE CONSTRUCTION JOINT

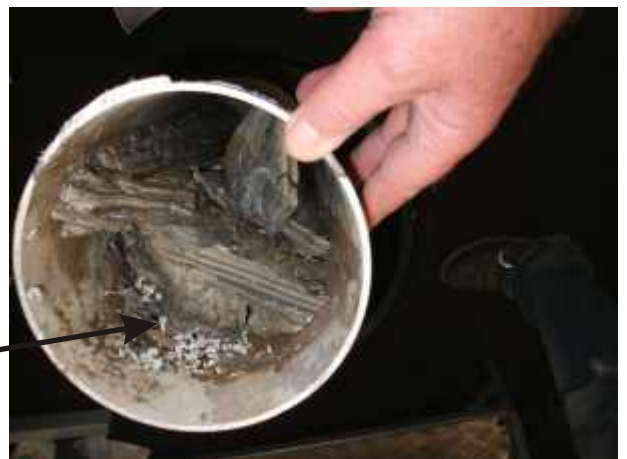
Here is a **WARNING** for the builder, this is a 150mm stormwater pipe. The strata layers are a job time line, the buildup blocked 2/3rds of the drainage system .
