MOUNTAINS HOME WITH MOUNTING PROBLEMS

April Showers Waterproofing was chosen because they could diagnose, specify and carry out the complete repair.

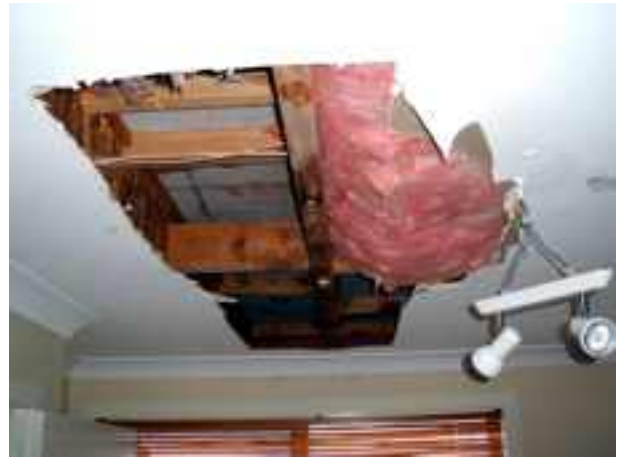
ANOTHER AREA OF CEILING DAMAGE

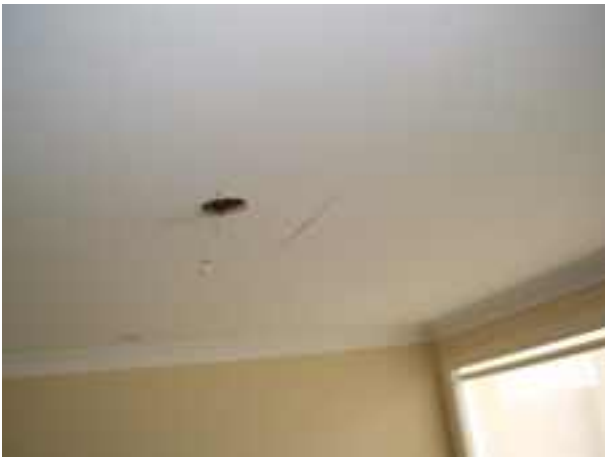
EVERY TIME IT RAINED OUT CAME THE BUCKETS

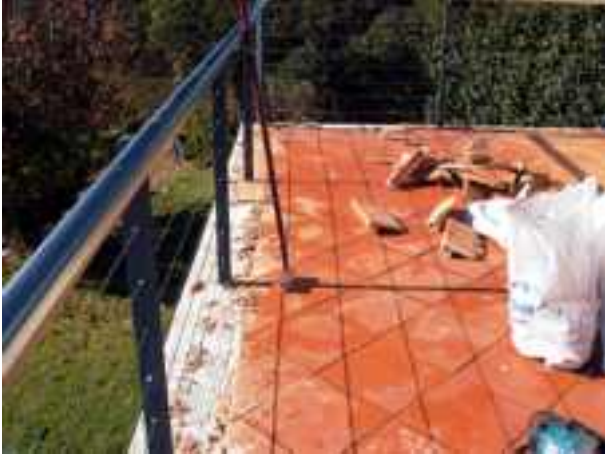
REMOVING THE TILES

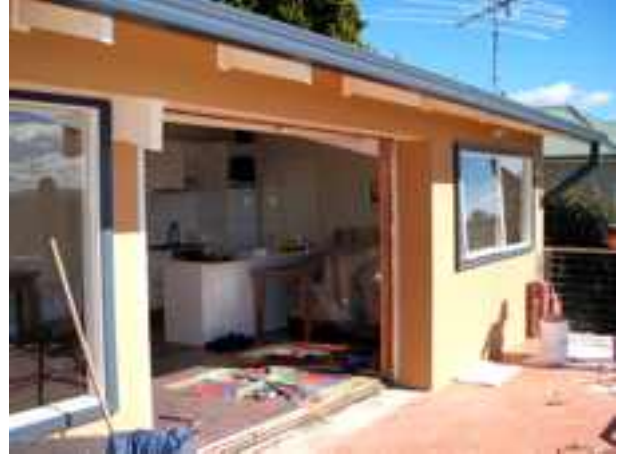
FIRST STEPS REMOVE DOORS AND FRAMES

The door frame removal is generally the first step of the repair procedure. It allows for the immediate installation of the sheet PVC membrane system to be installed behind and under the sill.

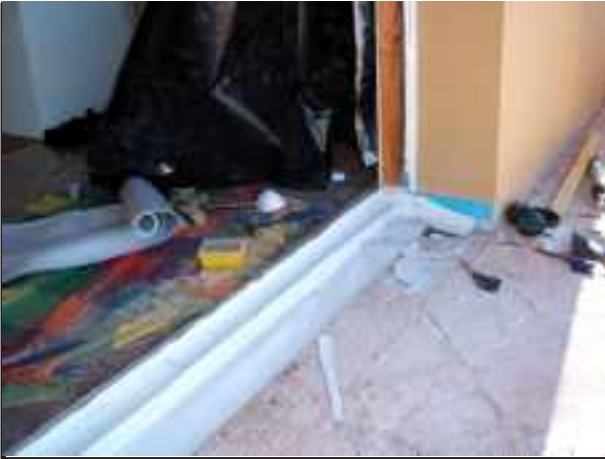
DOOR FRAME OUT NEW SHEET PVC MEMBRANE INSTALLED

As there is no cure time required by the membrane system it allows us to get the door frame back into position in the same day. The advantage of this procedure is that the interior of the home becomes secure from the elements as well as preventing dust and debris from further external work entering the home.

The leading edge lapping out from under the door sill will be heat welded to the main membrane system.

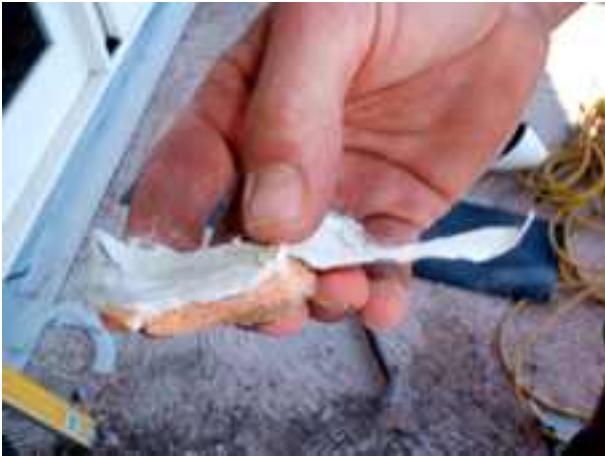
YEP! YOU BETTER BELIEVE IT, ANOTHER ACRYLIC MEMBRANE FAILURE.

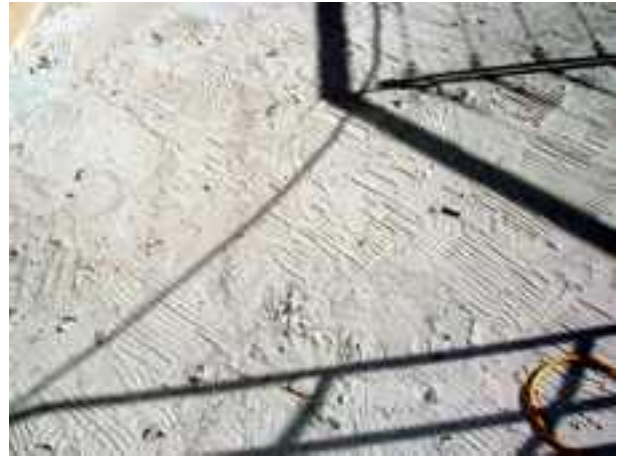
WE HAVE TO TURN THIS ROUGH SURFACE

INTO A SMOOTH UNIFORM SURFACE BY GRINDING WITH A DIAMOND FACED GRINDER.

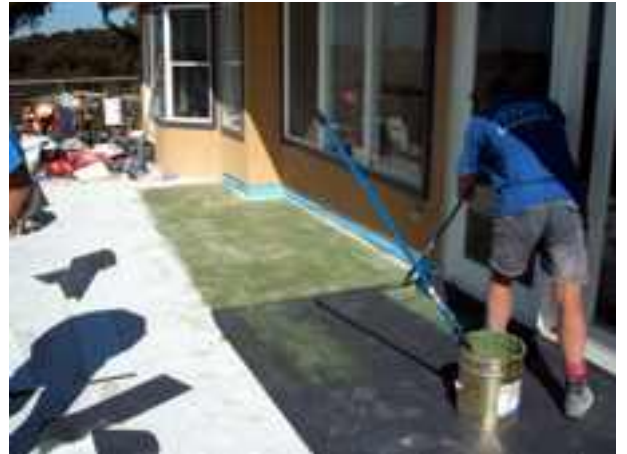
WE DECIDED WE WOULD BOND THE PVC MEMBRANE TO THE SUBSTRATE

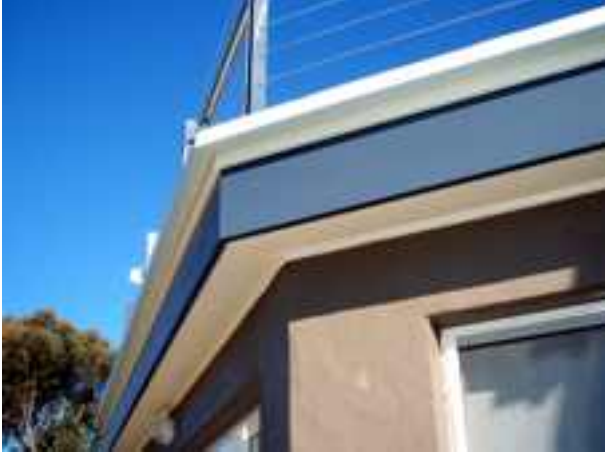
✓ A MEMBRANE COATED METAL PROFILE WAS FABRICATED TO FORM A PROPER RUN OFF EDGE

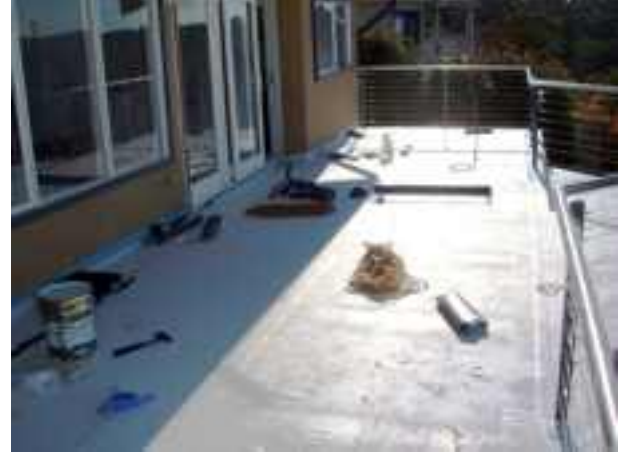
✓ THE PVC MEMBRANE INSTALLATION IS COMPLETED AND WATERTIGHT, TIME TO INSTALL A TOPPING SCREED

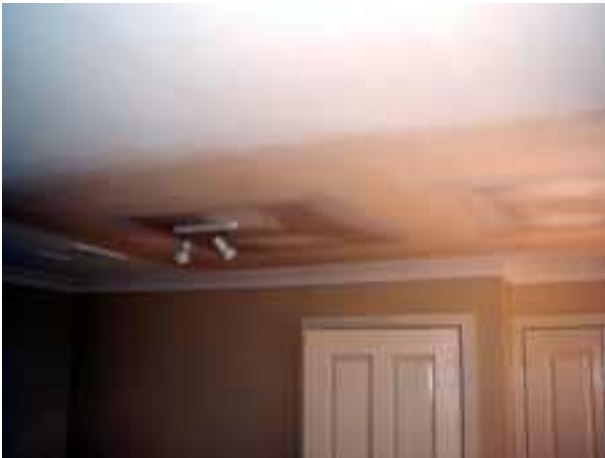
✓ WHILE THE TOPPING SCREED CURES WE CARRIED OUT REPAIRS TO RECTIFY THE WATER DAMAGED CEILINGS

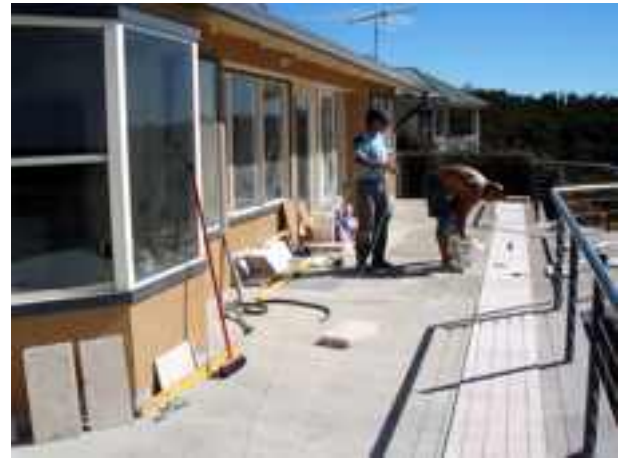
✓ TILE SET OUT IS VERY IMPORTANT ALLOWING FOR EXPANSION & CONTRACTION

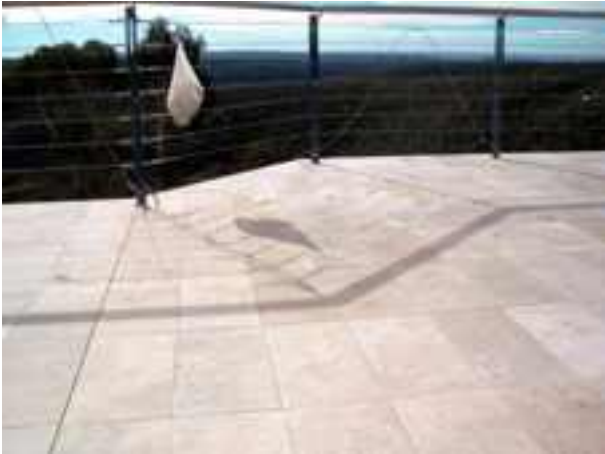
✓ EXPANSION JOINTS ALLOW FOR MOVEMENT

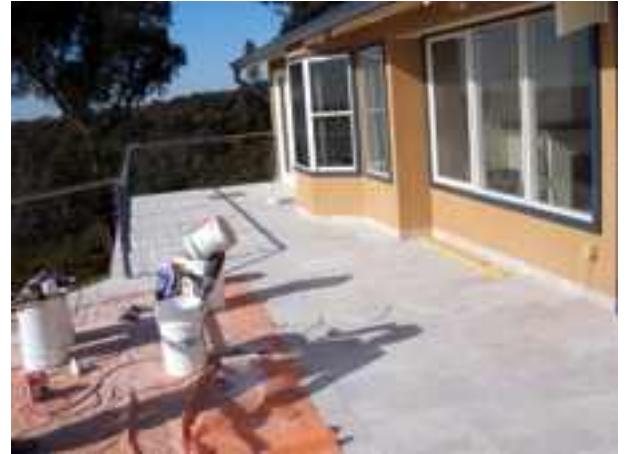
✓ ALMOST FINISHED, GROUTING YET TO BE DONE

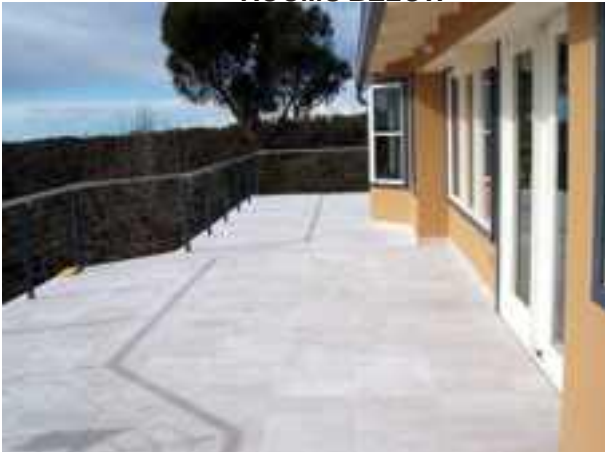
✓ LIGHT COLOURED TILES WERE CHOSEN AS THEY REDUCE THE HEAT IN THE ROOMS BELOW

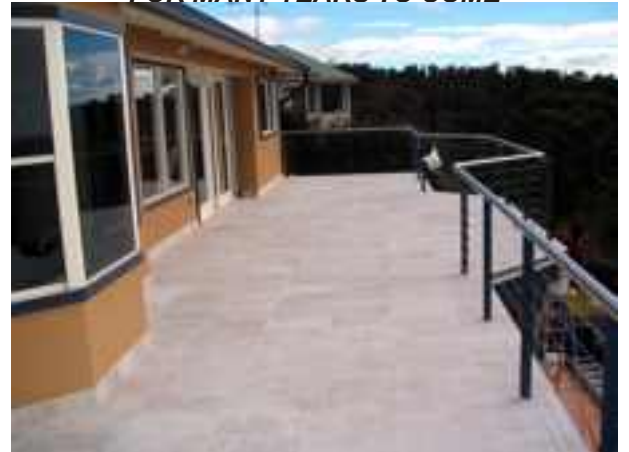
✓ THIS COMPLETED REPAIR WILL STAY WATERTIGHT & MAINTENANCE FREE FOR MANY YEARS TO COME
