WESTERN SUBURBS CASCADES

April Showers Waterproofing was called on for help when the two main tenants of a western suburbs shopping mall ceased paying rent because of the ongoing intrusion of water from their ceilings.

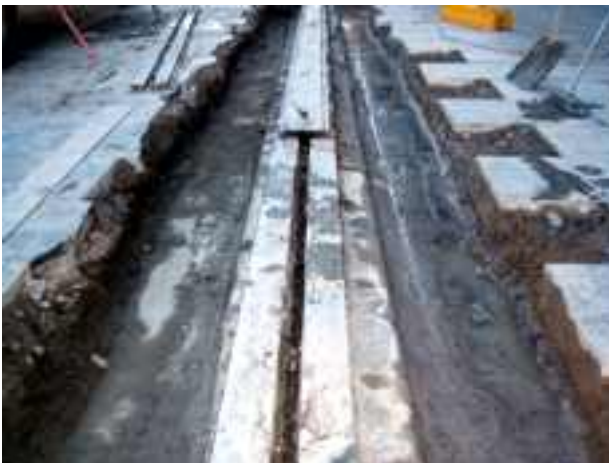
EXCAVATION AND CLEAN UP

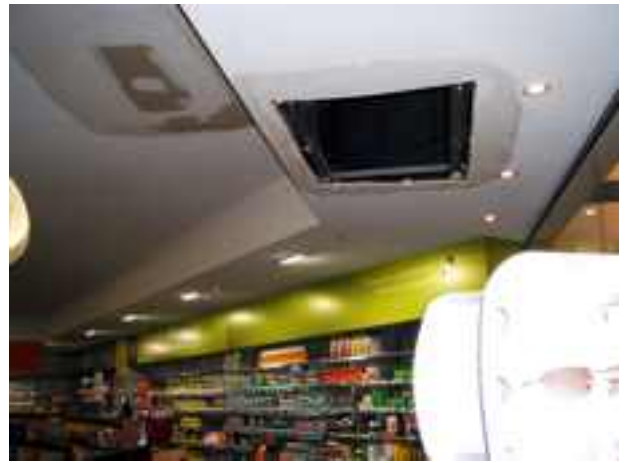
CEILING PATCHED BEFORE
EVENTUALLY IT FELL DOWN AGAIN

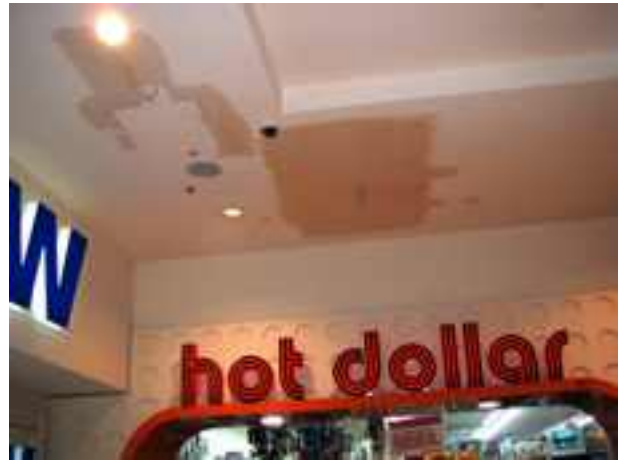
NEW PATCHES
NEW WATER LEAKS SHOWING

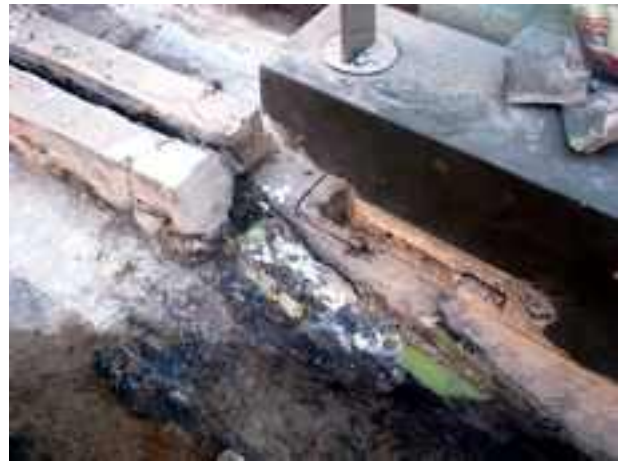
AND UNDER THE BLOB
THE CONSTRUCTION JOINT

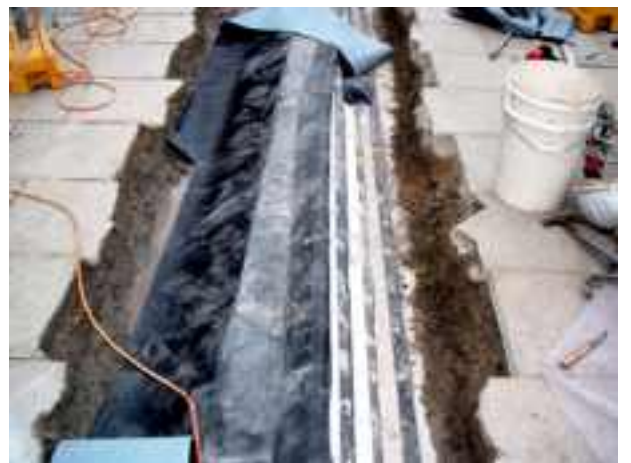
PROFILING AND CUTTING TO SIZE

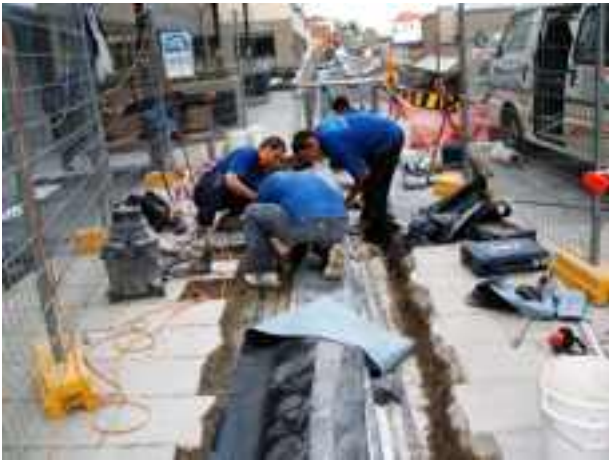
HEAT WELDING THE PVC TOGETHER

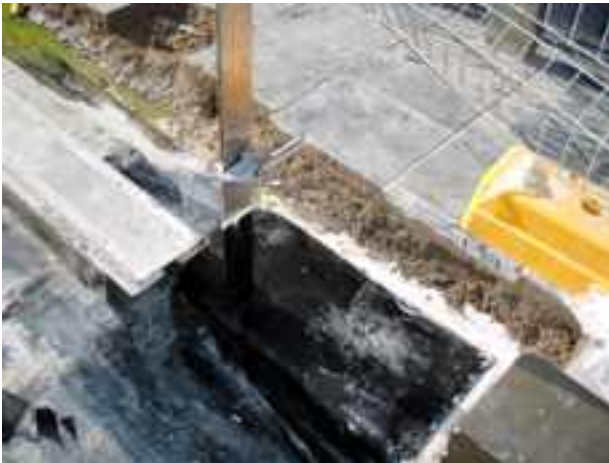
PROPER MEMBRANE TERMINATION REPLACES THE BLOB

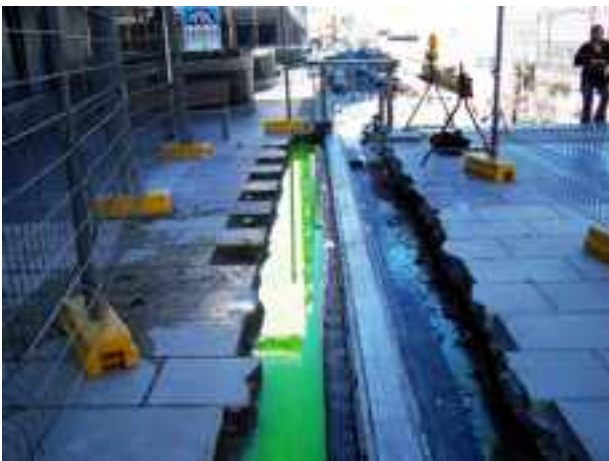
FLOOD TESTING WITH DYE WHEN PRACTICAL. "NO LEAKS"

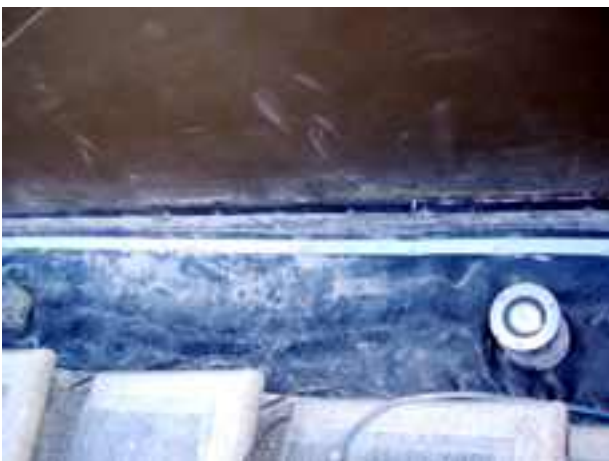
**PVC MEMBRANE INSTALLED
DETAIL WELDING NEXT**

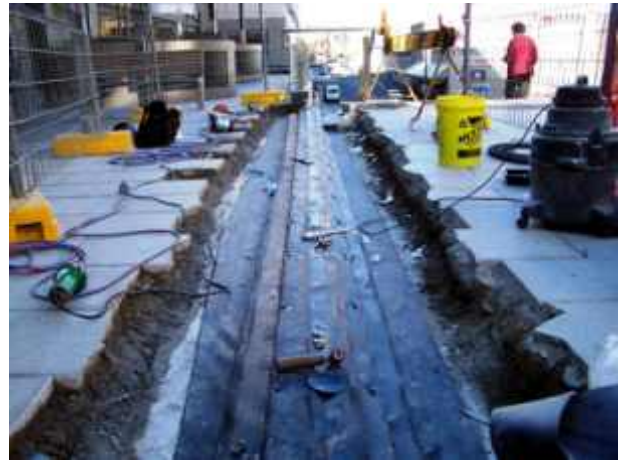
**HEAT WELDING THE PVC MEMBRANE
TOGETHER COMPLETED**

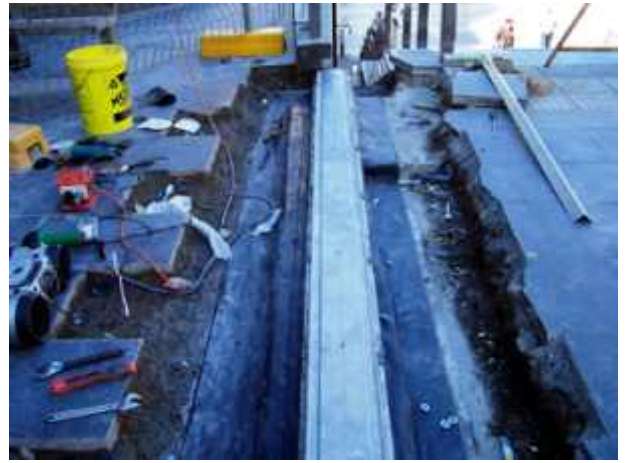
**THE EXPANSION JOINT COVER PLATE
IS BOLTED BACK IN POSITION**

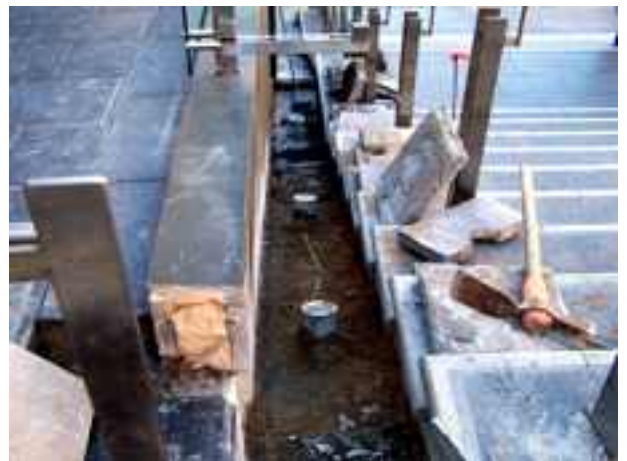
**WE HAD TO CONTINUE DOWN THE STEPS
TO FOLLOW THE CONSTRUCTION JOINT**

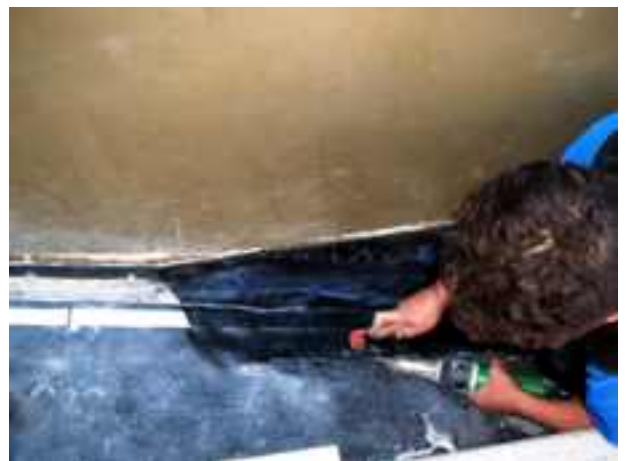
**HOT AIR WELDING THE MEMBRANE
PARTS TOGETHER**

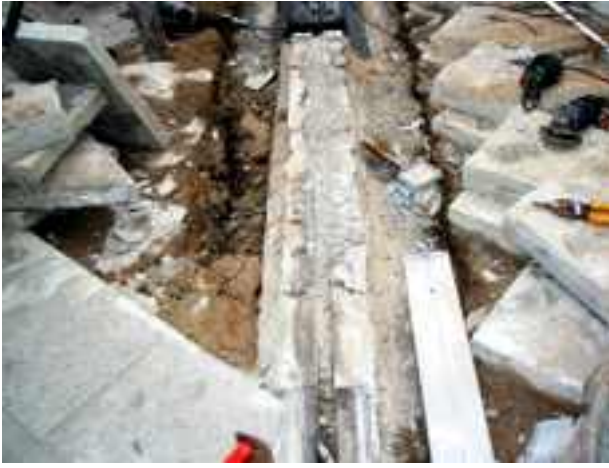
**STAGE 2
THE EXCAVATION**

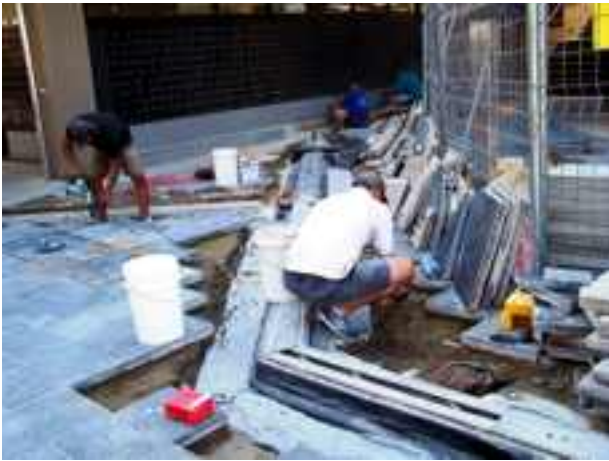
**WE ADDED A DRAINAGE CELL
NEXT TO THE FINISHED MEMBRANE AREAS**

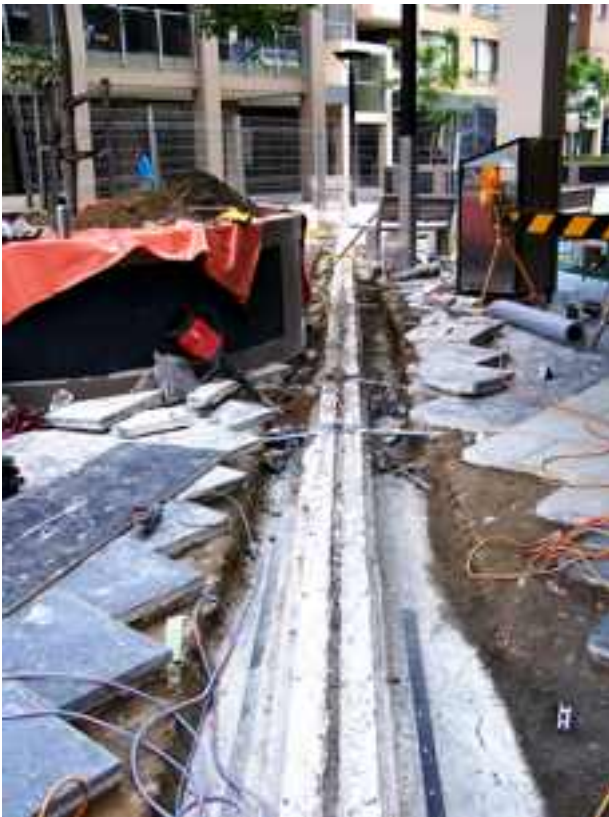
**EXTENDING OUT TO THE
MIDDLE OF THE PODIUM**

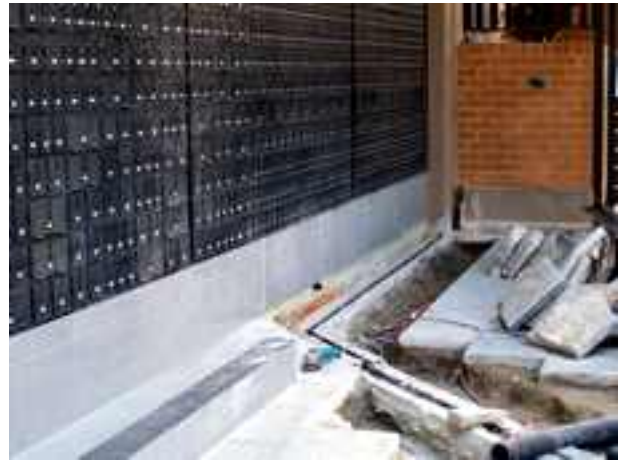
**STAGE 2
IN FRONT OF THE P.O. BOXES**

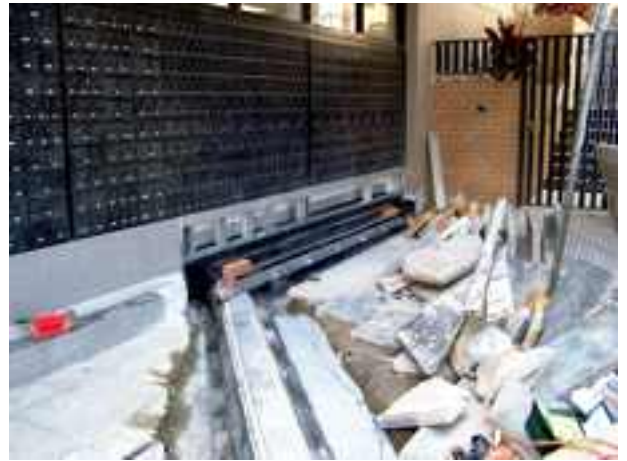
P.O. BOX SECTION FINISHED

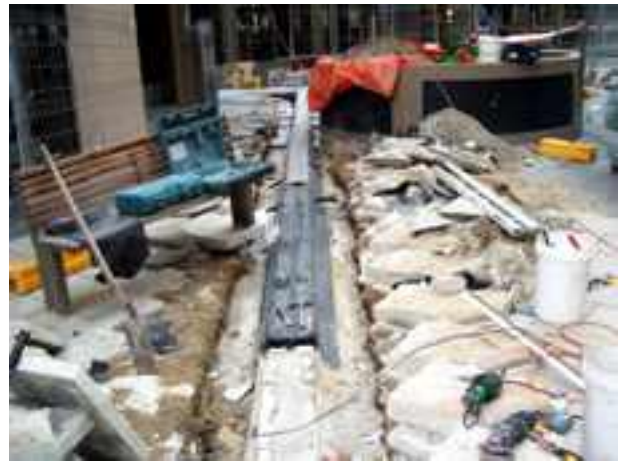
**GETTING CLOSE TO THE
END OF OUR WORK**

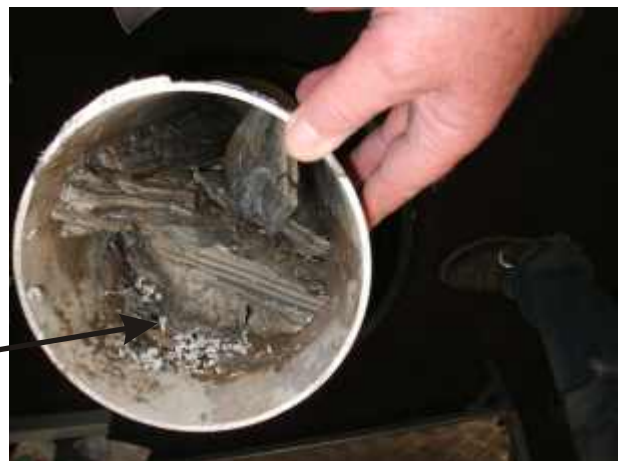
Here is a **WARNING** for the builder, this is a 150mm stormwater pipe. The strata layers are a job time line, the buildup blocked 2/3rds of the drainage system .
