CURE FOR WATERFRONTAGE UNDER WATER

April Showers Waterproofing carried out waterfront rectification under instructions from the Office of Fair Trading on this home converted from an old boatshed.

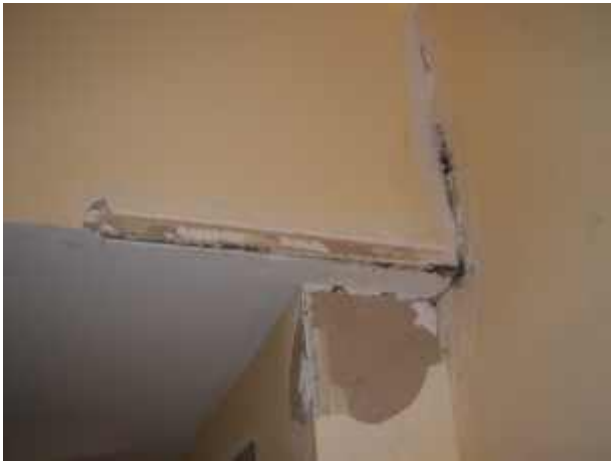
WATER LEAKS ALWAYS LEAVE A TRAIL

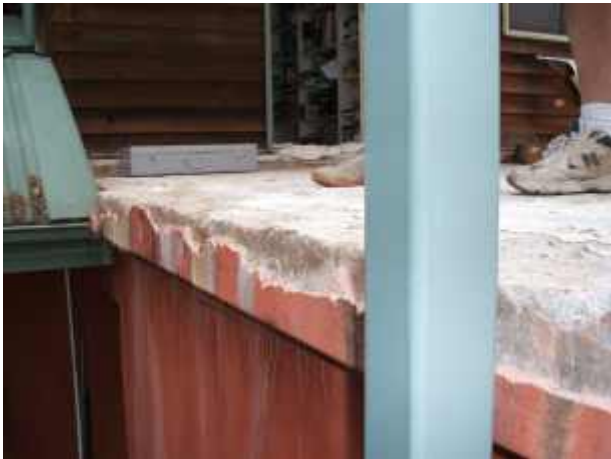
COMBINATIONS OF BUILDING MATERIALS

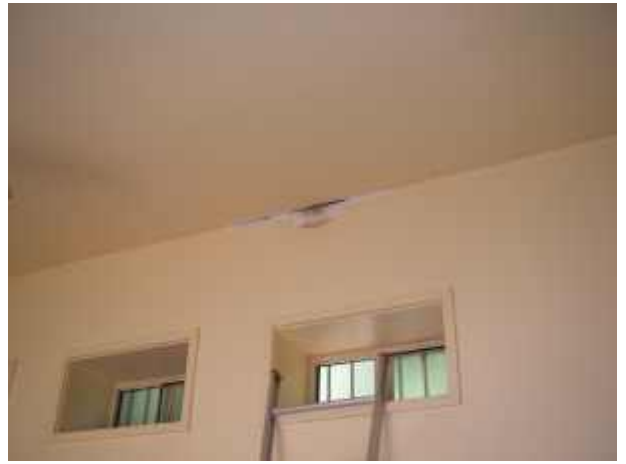
ANOTHER AREA OF DAMAGE
