## MAKING A SILK STOCKING FROM A SOWS EAR

The High Care Nursing Home was only two years old when problems became visible, these problems included:

The following diagrams were submitted by April Showers Waterproofing outlining the procedures we would take in carrying out the 33 required repairs in the South Coast Nursing Home.

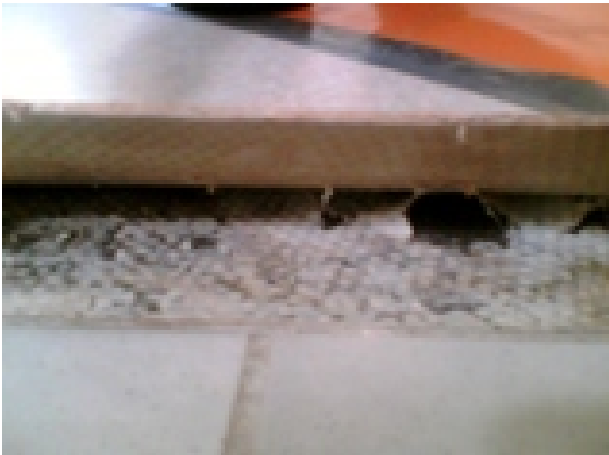
ESCAPING WATER BREAKS DOWN THE VINYL ADHESIVE

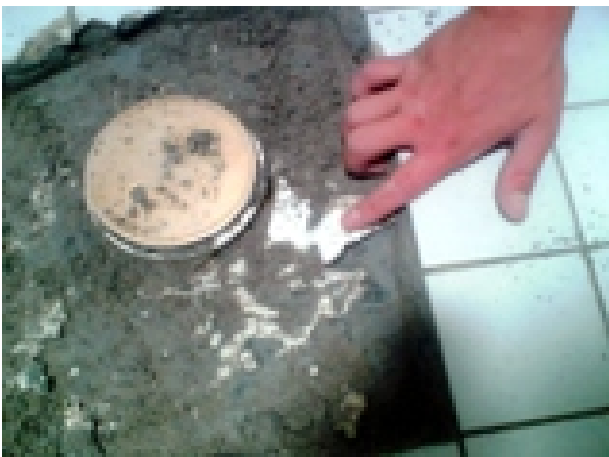
ACRYLIC MEMBRANE

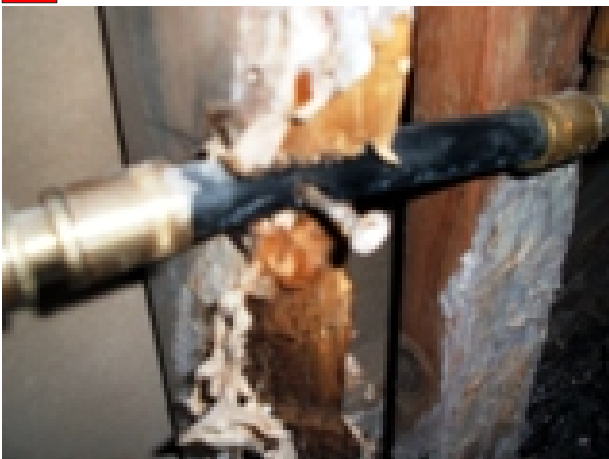
NAIL THROUGH WATER SERVICE

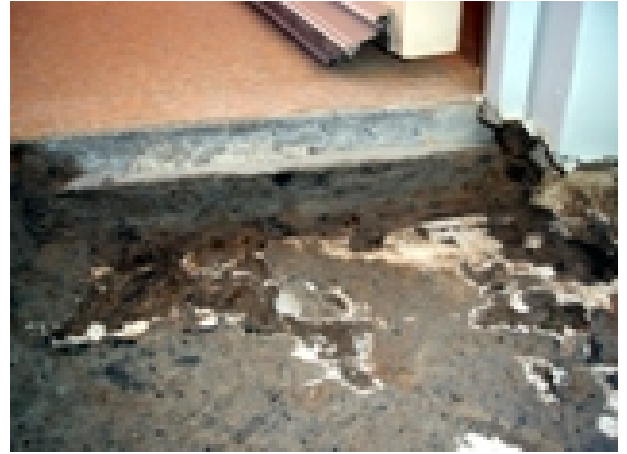
NO WATERPROOFING ONTO THE WATER STOP

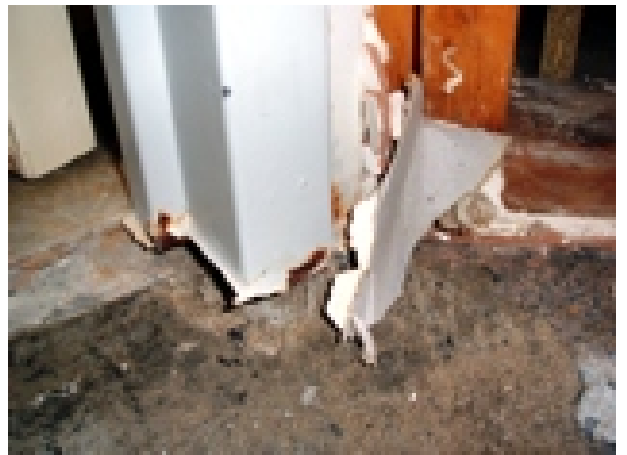
CORRODED STEEL DOOR JAMBS

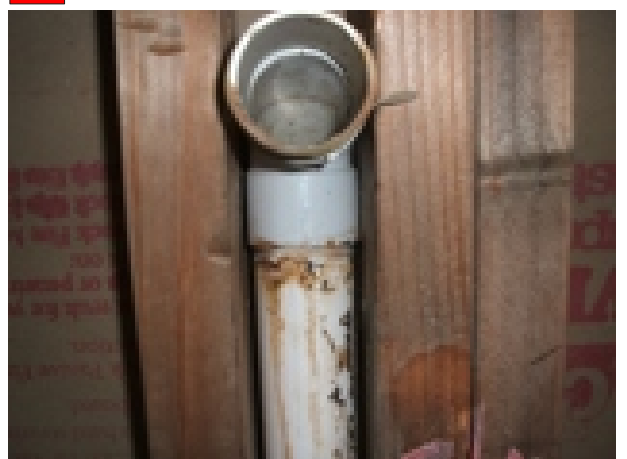
PVC BEND NOT GLUED
