1 OF 33 BATHROOMS

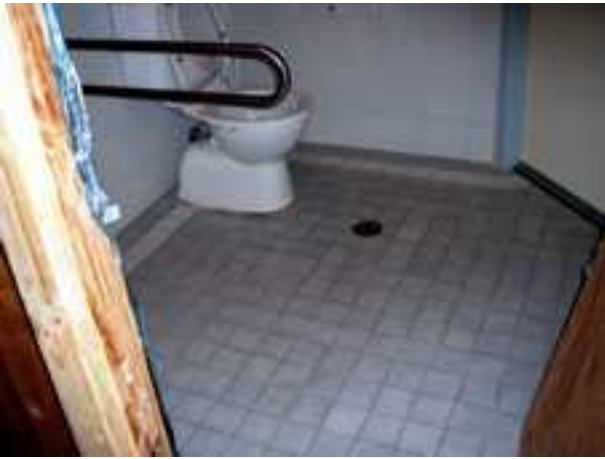
ESCAPING WATER BREAKS
DOWN THE VINYL ADHESIVE

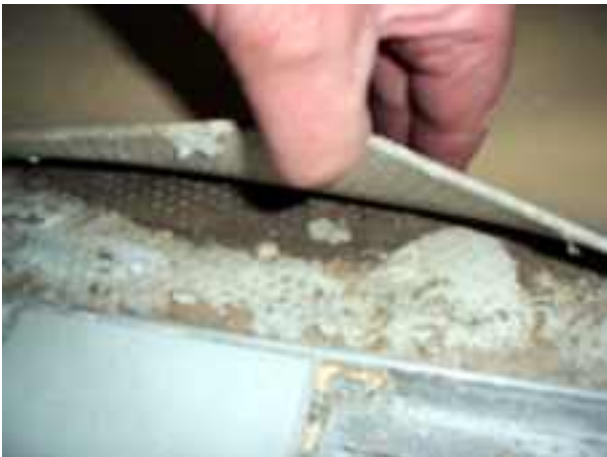
ACRYLIC MEMBRANE
