THE HOME IN QUESTION

THIS BALCONY IS THE HEART OF THE PROBLEM

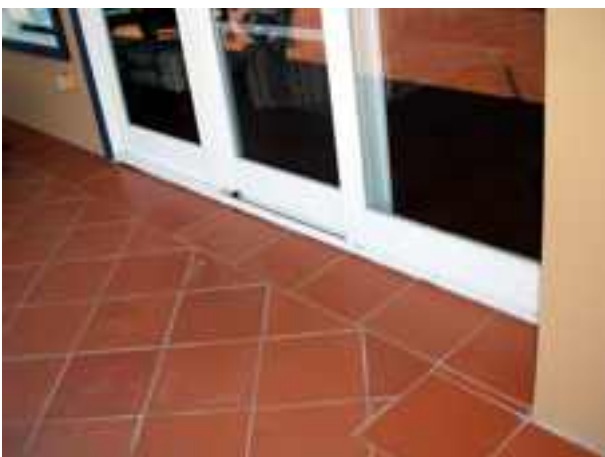
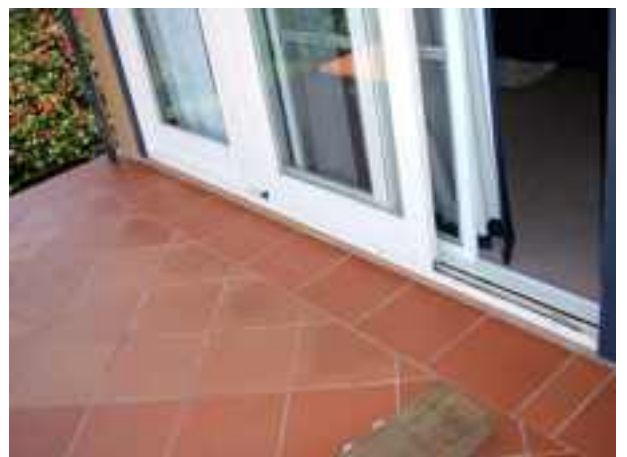
AND THIS AS WELL

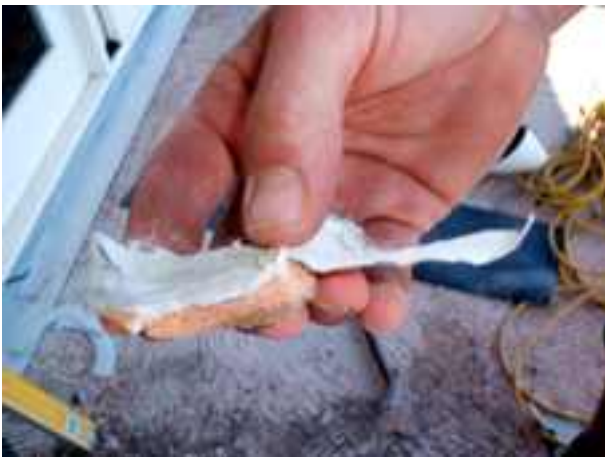
YEP! YOU BETTER BELIEVE IT, ANOTHER ACRYLIC MEMBRANE FAILURE.

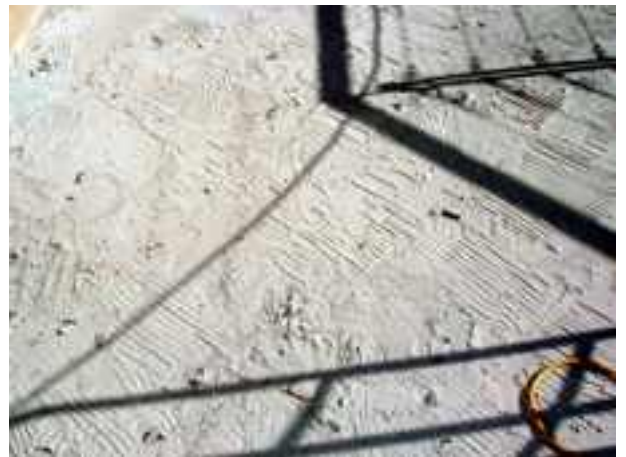
WE HAVE TO TURN THIS ROUGH SURFACE

INTO A SMOOTH UNIFORM SURFACE BY GRINDING WITH A DIAMOND FACED GRINDER.
