BEACHSIDE RESCUE FOR DROWNING HOME

The owners of this beachside home were appalled at the intrusion of dampness from the area between their house and that of the neighbour.

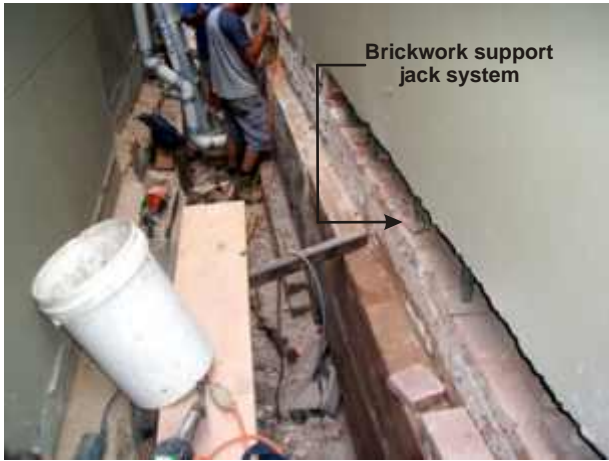
THIS SITE HAD TO BE EXCAVATED FIRST

Brickwork support
jack system

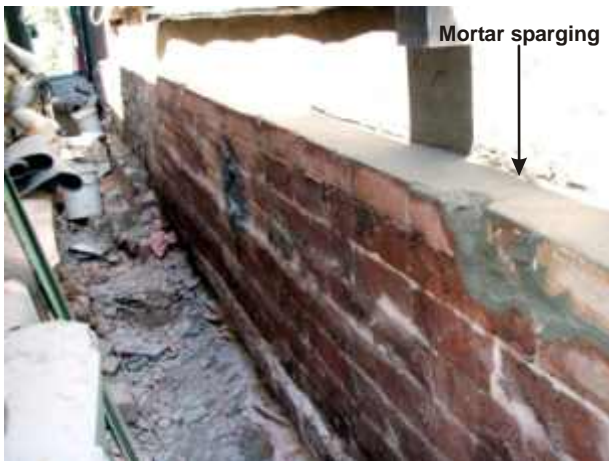
AIDING THE MEMBRANE TRANSITION

Mortar sparging

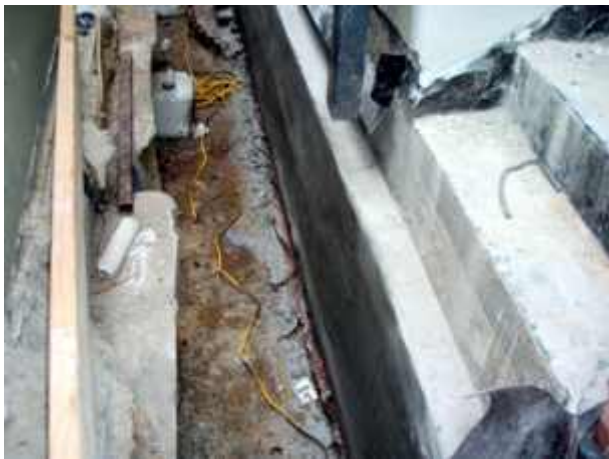
**EVERY PART OF THE PVC MEMBRANE
IS HEAT WELDED TOGETHER**

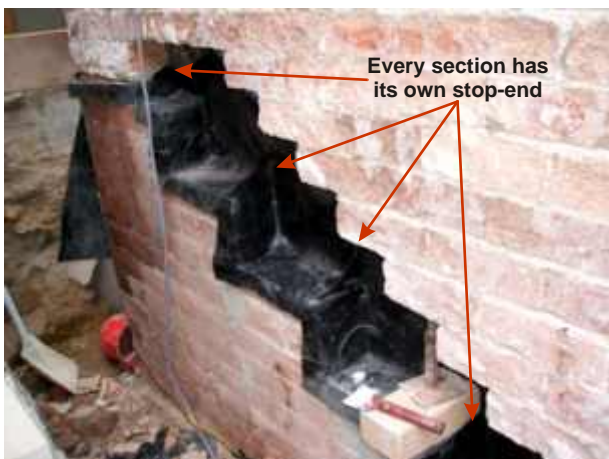
**CAVITY STEP FLASHING AT THE OTHER
END OF THE BUILDING**

Every section has
its own stop-end

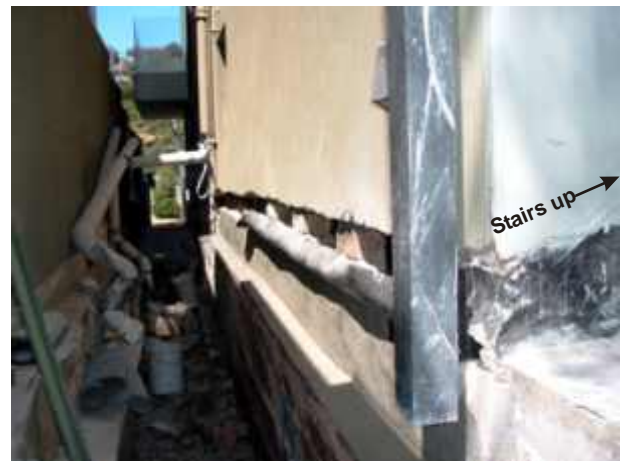
HEAT WELDING EVERY PART TOGETHER

Stairs up

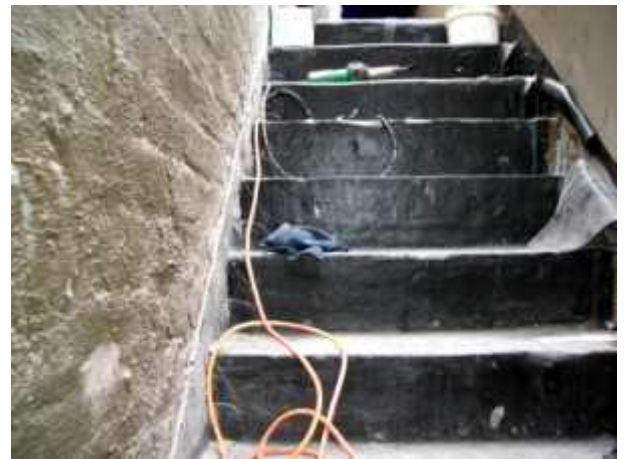
**THE STAIRS ARE ENCAPSULATE &
WELDED TO THE CAVITY FLASHING**

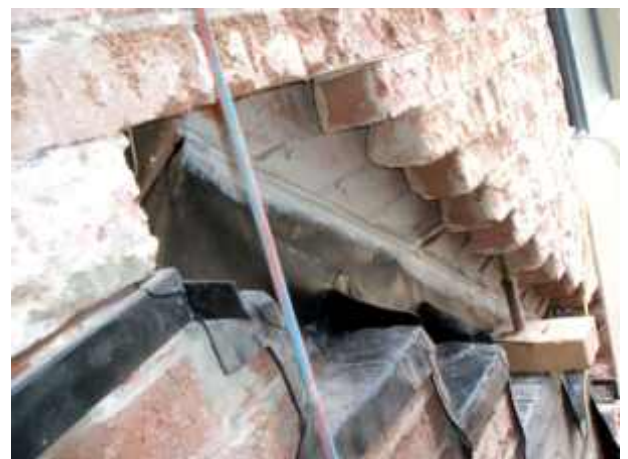
A BETTER VIEW

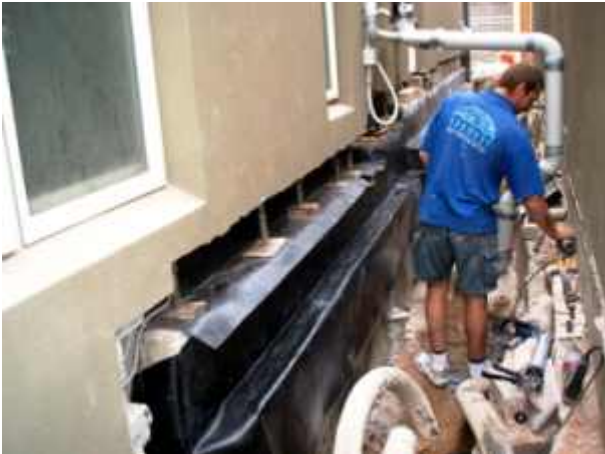
THE MAIN PVC MEMBRANE AREAS ARE INSTALLED

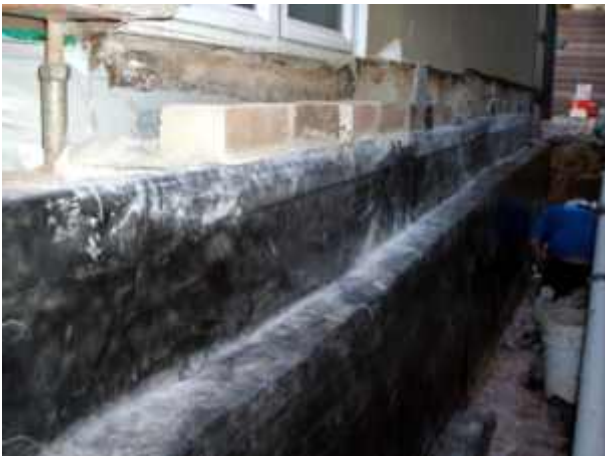
WELDING OFF THE BASE TERMINATION

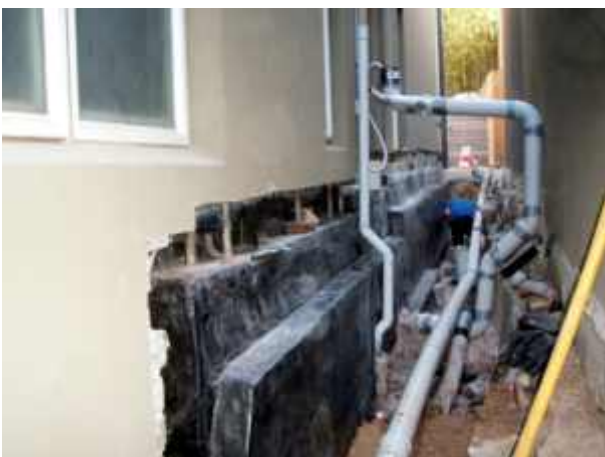
SO CLOSE TO COMPLETION

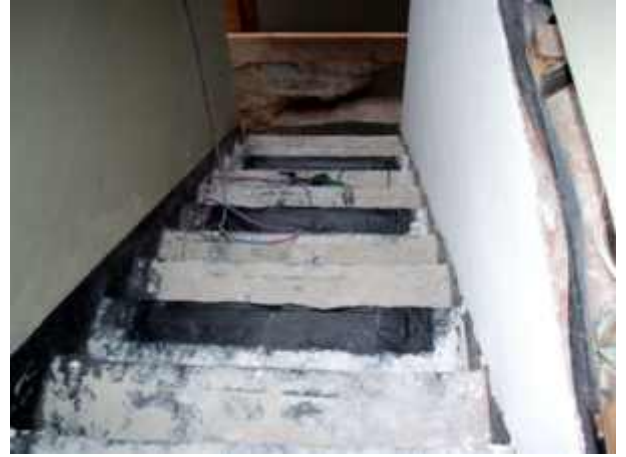
THE PVC MEMBRANE OVER THE STAIRS COMPLETED

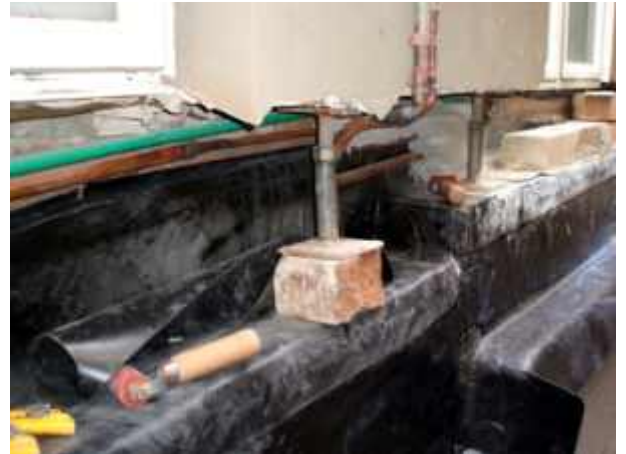
DETAILING THE CHANGES OF DIRECTION

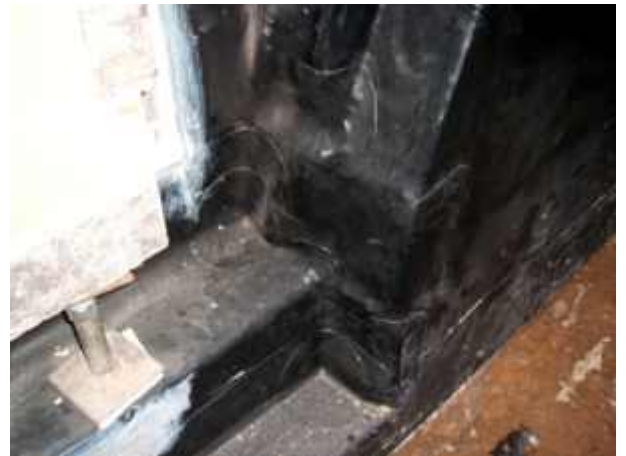
ALL VERY TIME CONSUMING RESULTING IN A PERMANENT SOLUTION

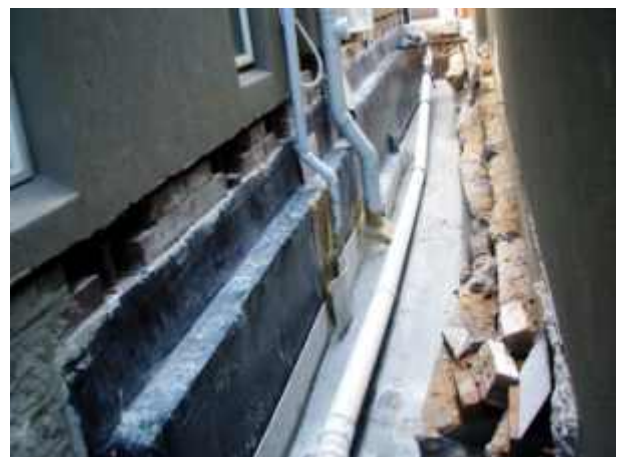
ALL THAT IS REQUIRED NOW IS BRICKWORK, RENDER & PAINT
